TEST REPORT

No. : SHIN2102008701ML

Sample Name : OX HORN CARABINER

Tensile Test:

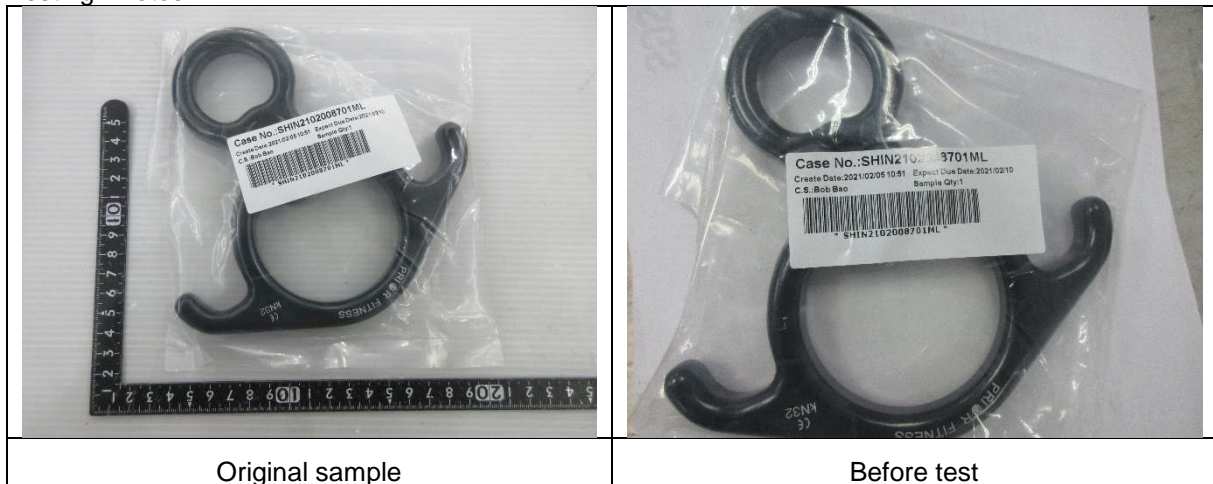
Testing Photos:

Step 1. Fix the sample on the test equipment, please see the test photos;

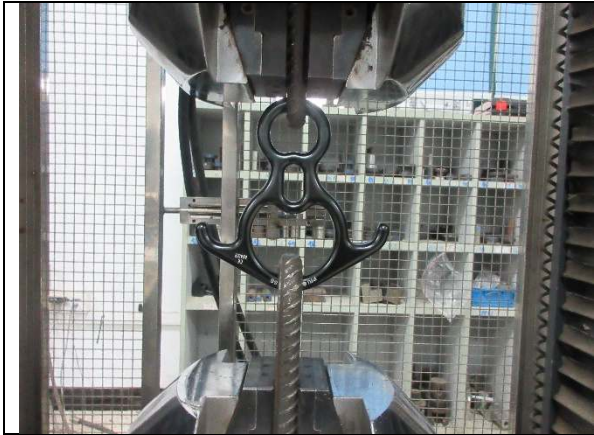
During test

Step 2. Drawing at the certain rate until the sample was broken;

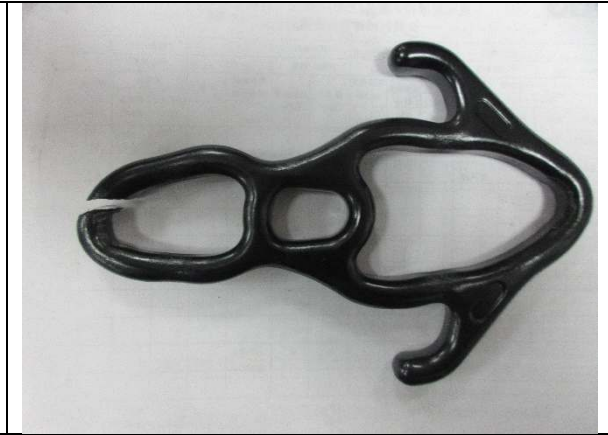
After test

Step 3. Check the location of fracture and record the force.

Sample	Broken force (kN)	Req. (kN)	Results	Location of fracture
1#	65.79	32	Pass	See photos

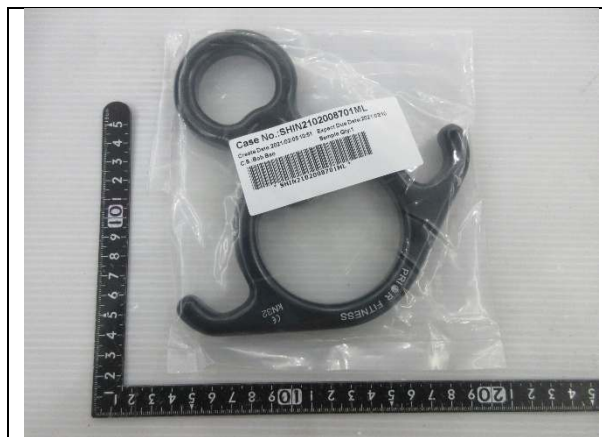
Sample Photo
